LANGLEY RESEARCH CENTER

SA-05-87

DATE: July 24, 1987

SUBJECT: Schrader Prep-Air Lub-Air-Ators

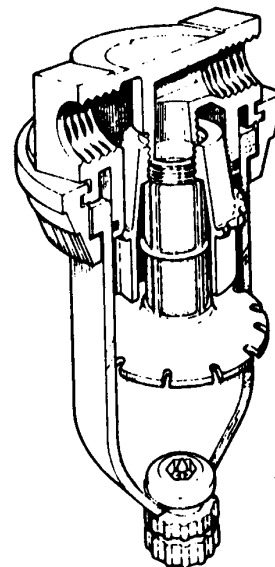
As a result of a failure of the subject equipment item, the Center is carefully examining all existing Lub-Air-Ators. The failed Lub-Air-Ator was equipped with a plastic bowl and rated for 150 psig, which should have been adequate for the nominal 125 psig service air line. It is believed that the failure could be due to overtightening during installation or maintenance plus an exposure to a high temperature environment.

We are asking that each Facility Coordinator survey his/her area and report to this Office the presence of any Lub-Air-Ators with plastic bowls, (Ref. pictorial view below). Your immediate response is requested.
